# Biological Safety Cabinet (BSC) Profiled Decontamination Validation Report

## Gaseous Decontamination with Chlorine Dioxide Gas

Report Number: BIO21021

Date of Report: April 7, 2021

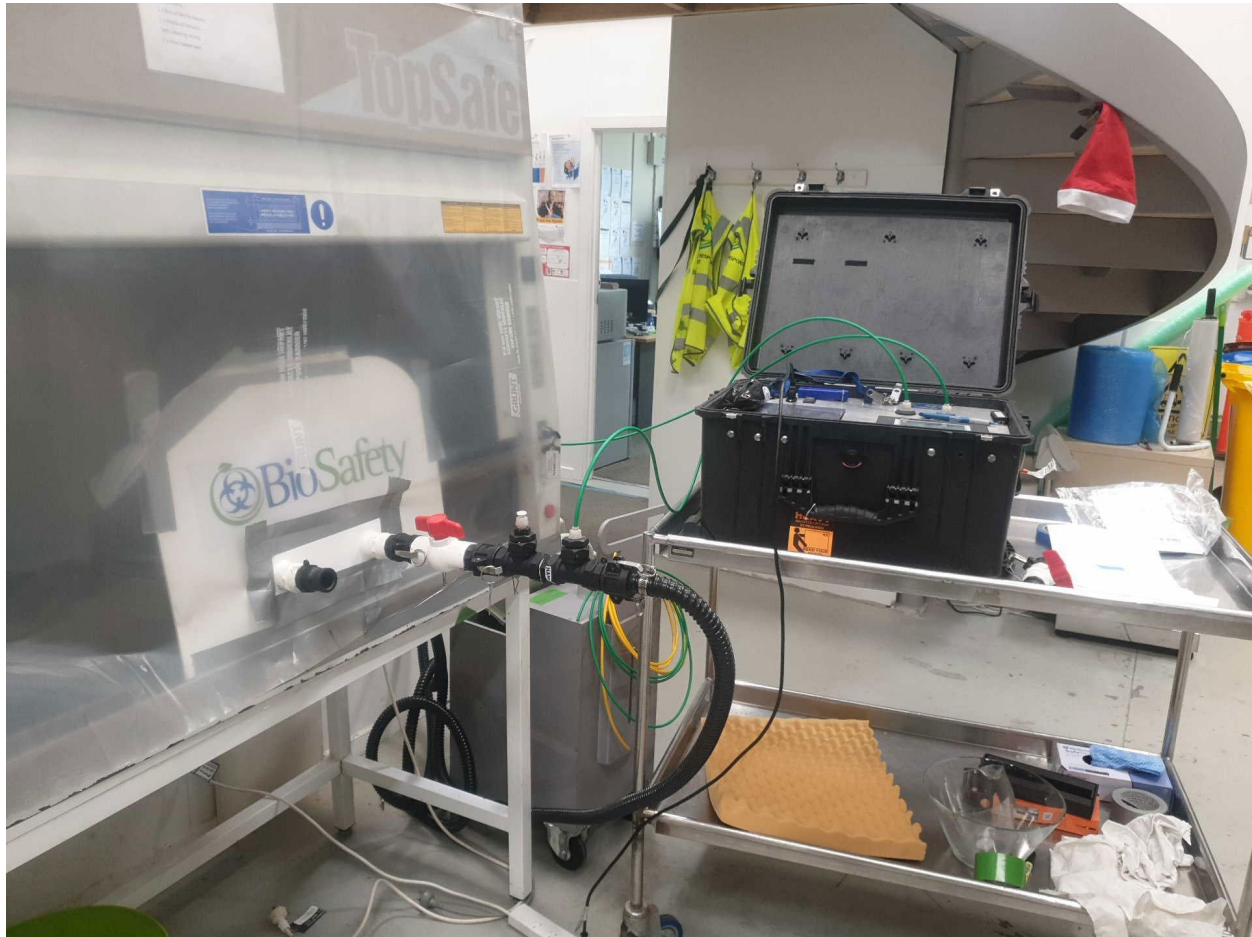
Decontamination Validation Set Up – Sealed BSC with recirculation blower, EMS real time gas monitoring

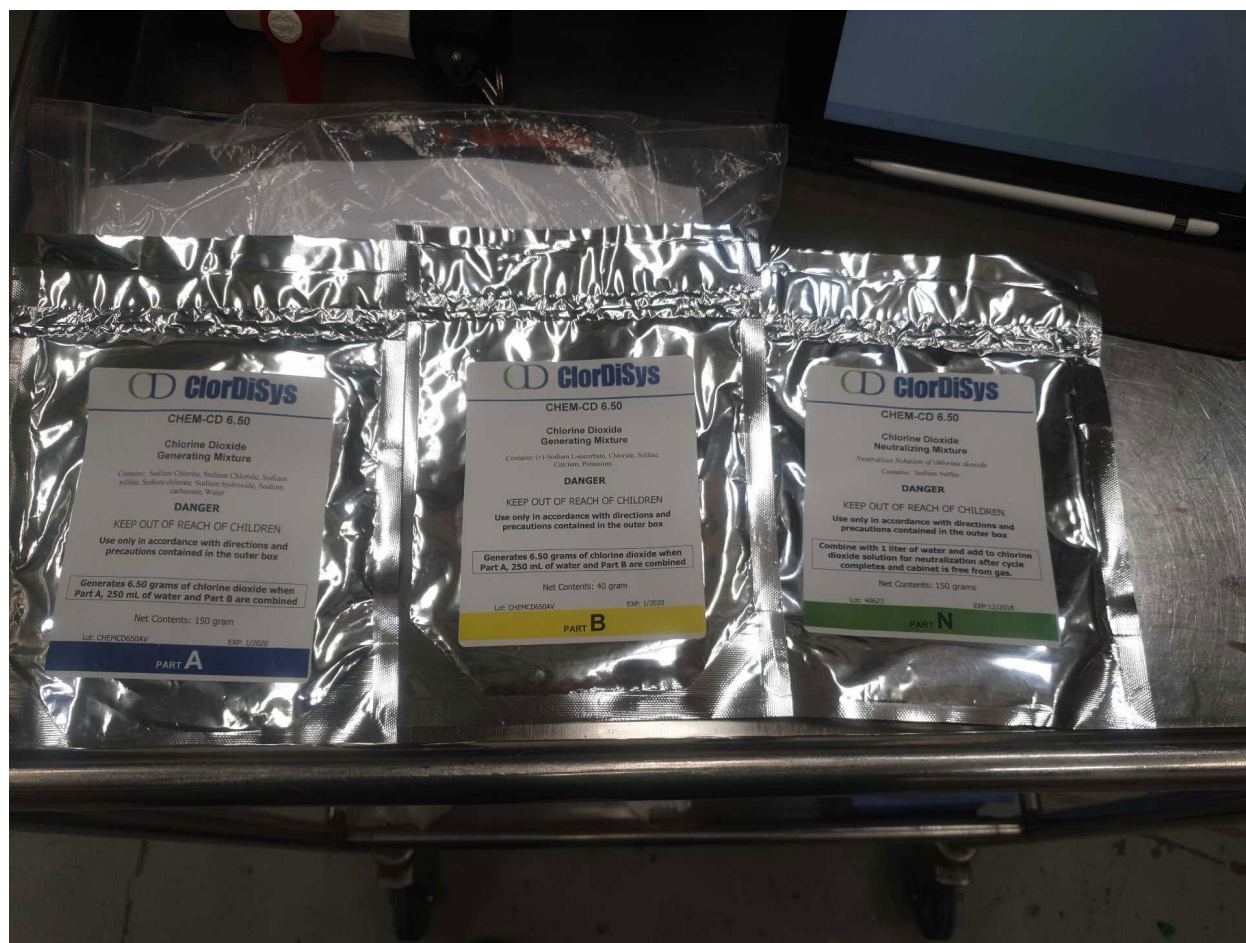
ClorDiSys ChemCD 6.5 Chlorine Dioxide Generating Kit

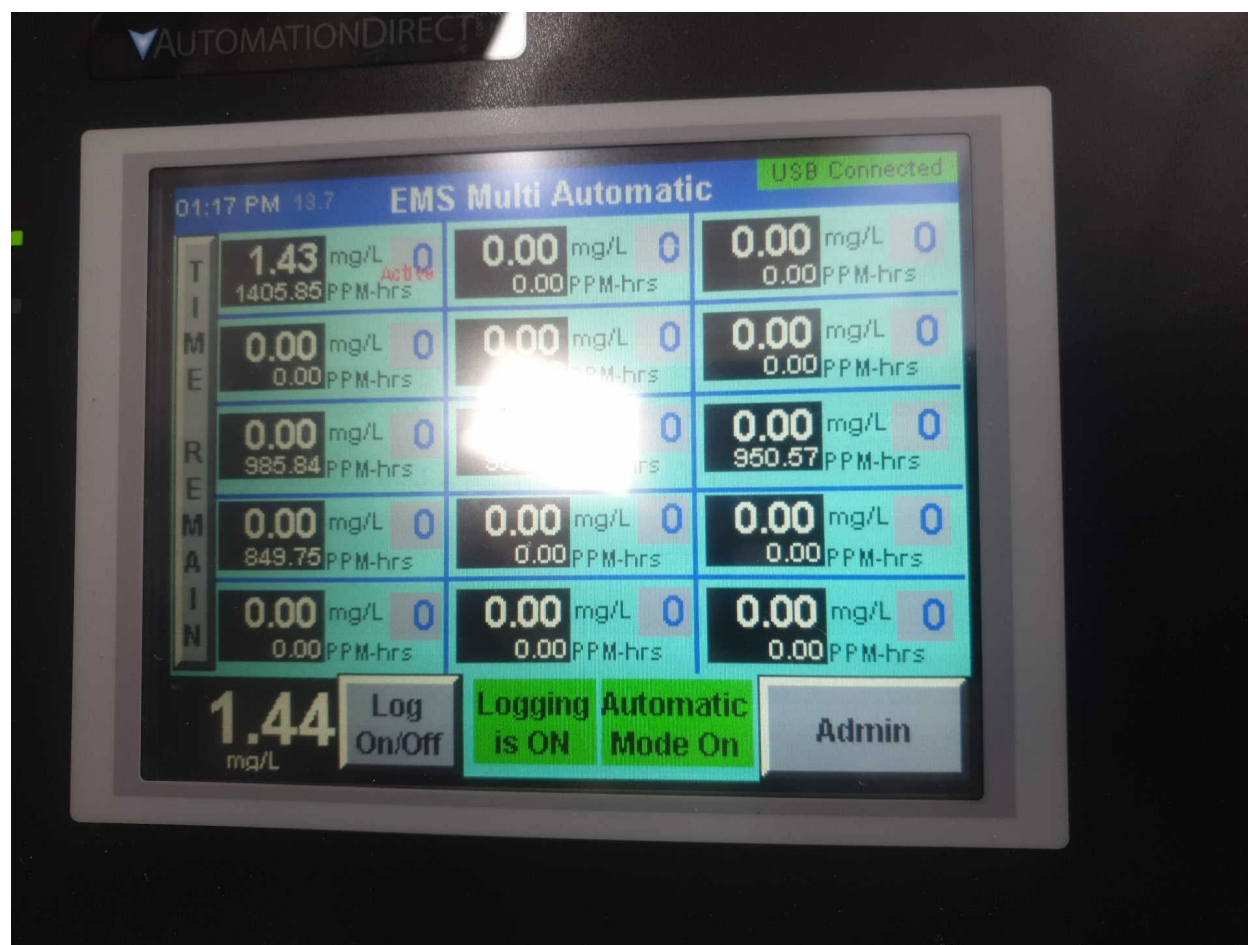
Exemplar EMS monitoring screen. Top left cell demonstrating 1.43 mg/L current concentration, 1405.85 ppm-hrs total accrued exposure

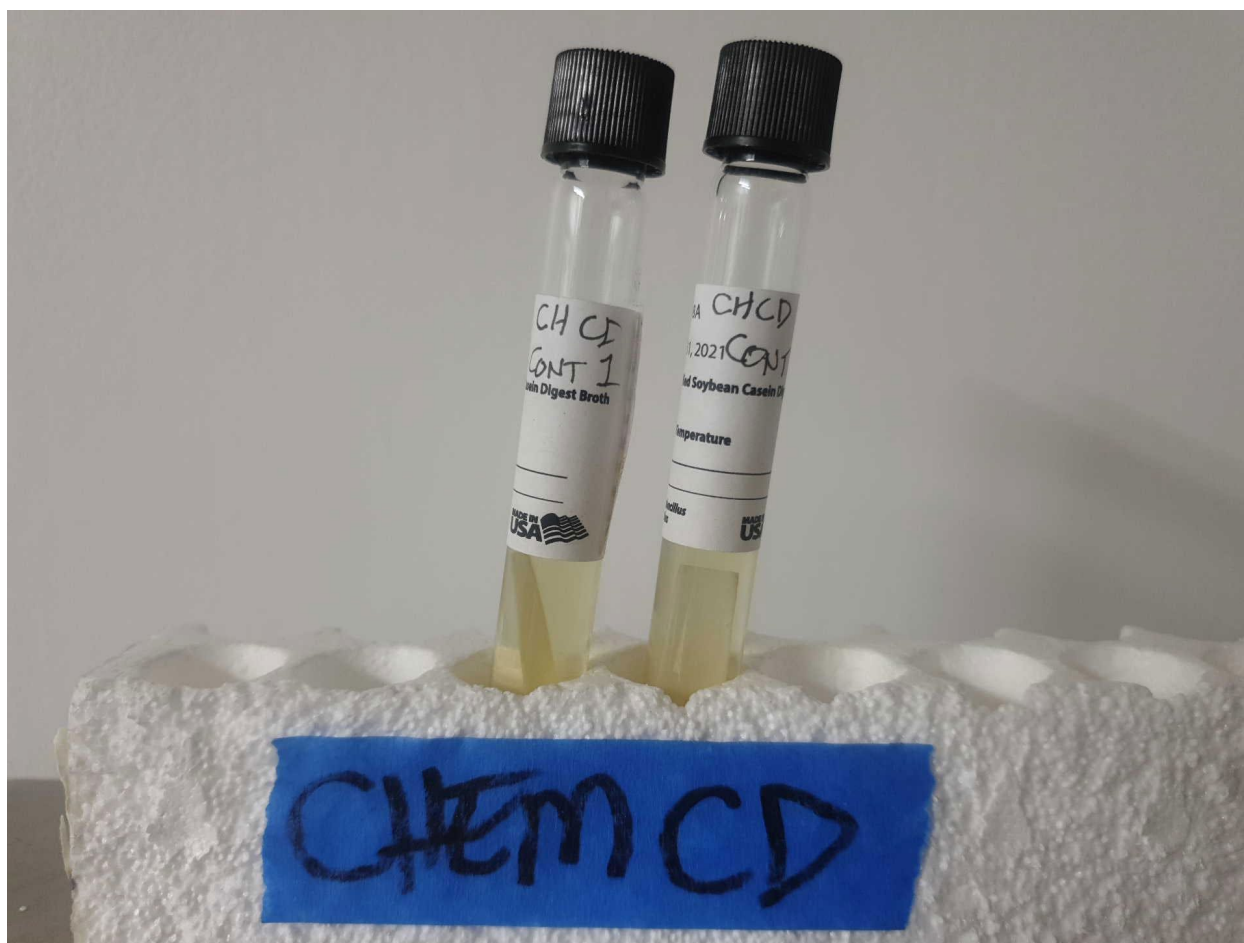
Biological indicator results for control pair – yellow media colour indicates a pH change as result of growth
